Observed Features on 9-cell Cavity RF Surface
and
Correlation with Gradient Failure Mode
- JLab Experience

Rong-Li Geng
Jefferson Lab

March 6, 2009, Cavity Vendor Meeting at FNAL

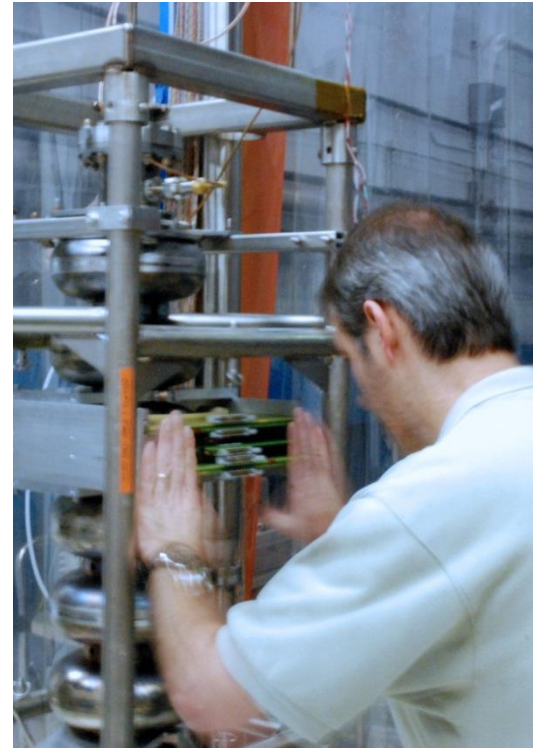
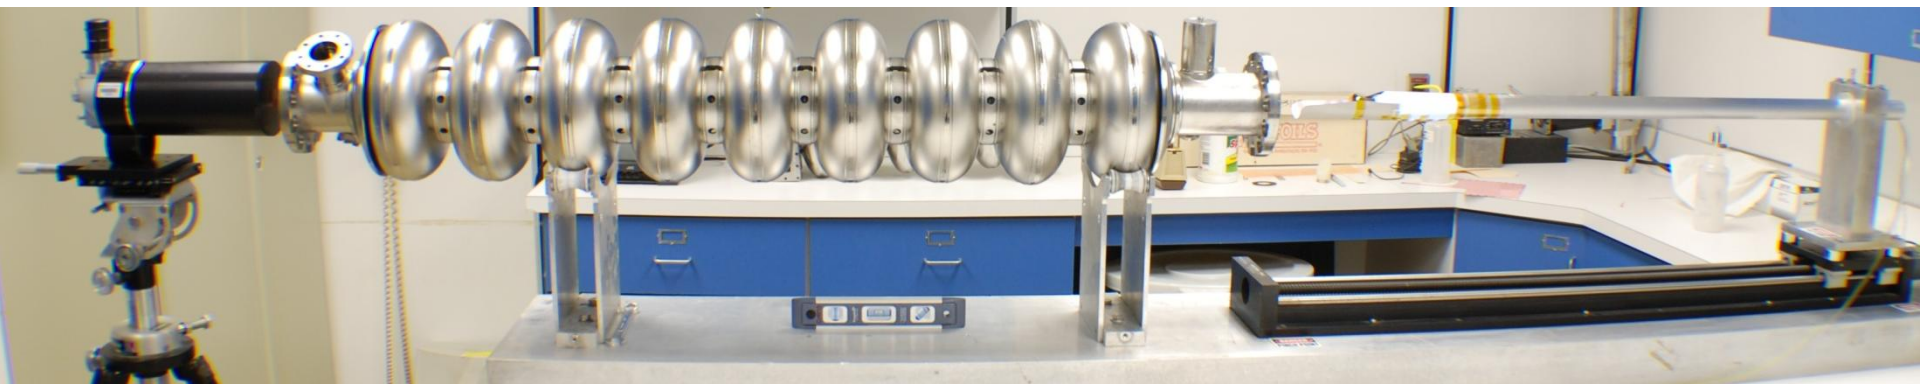
T-mapping Quench Cell Pair & Quarter Inspection

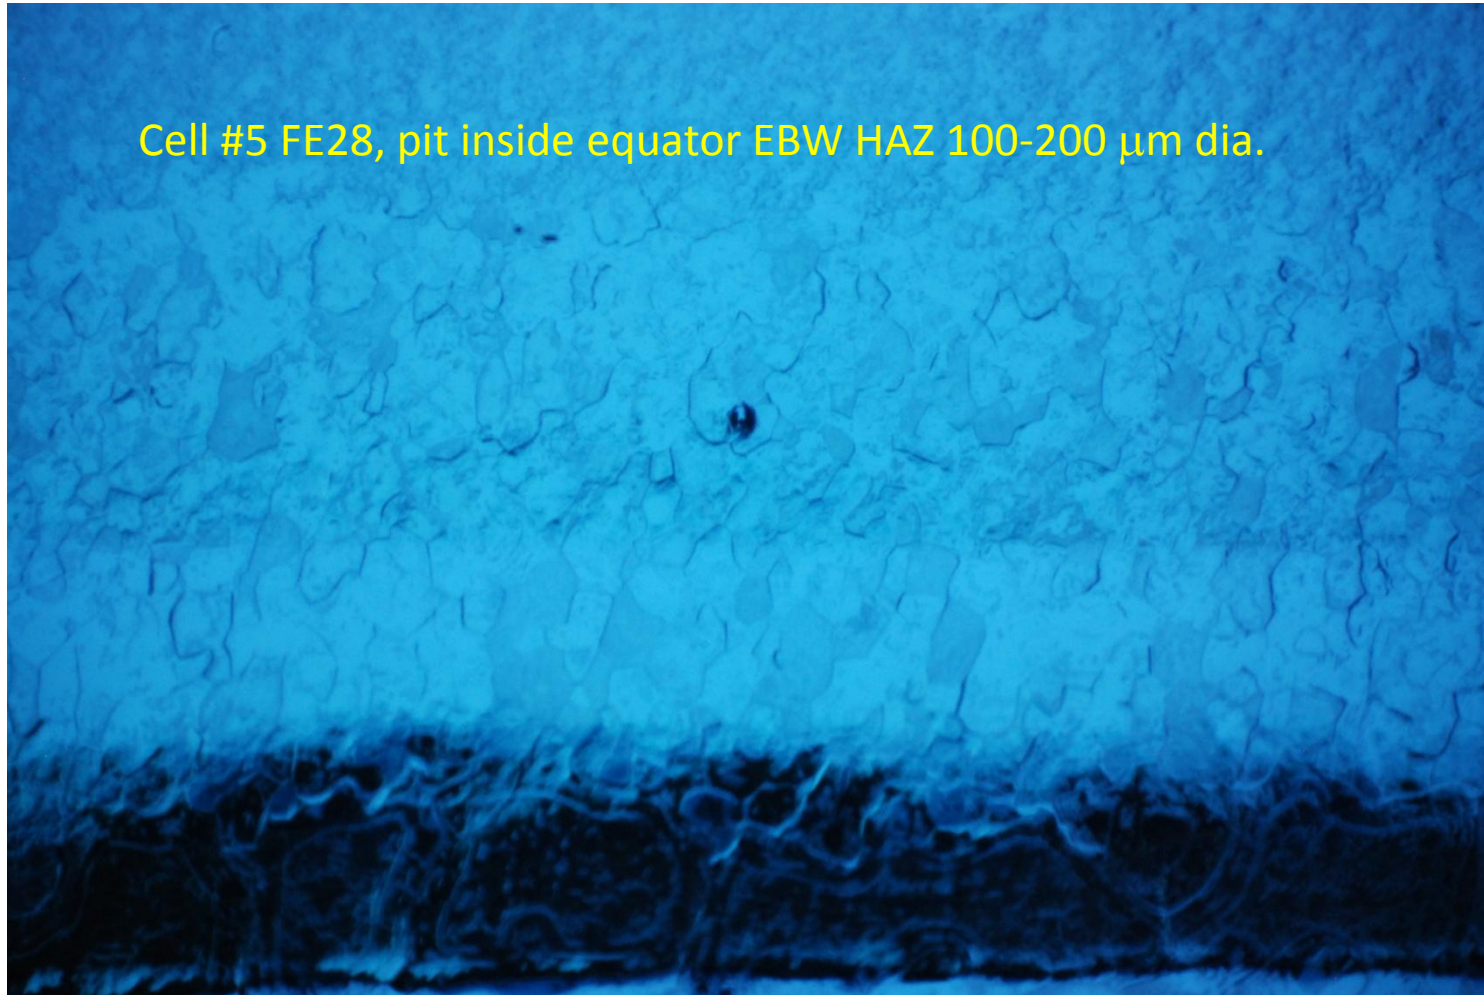
A13 Bulk EP + 600CX10hr Full Inspection

many pits of various sizes (50-200 μm dia.) inside & outside equator EBW HAZ

A13 was later light EP (20-30 μm removal) and reached 44 MV/m, further inspection pending

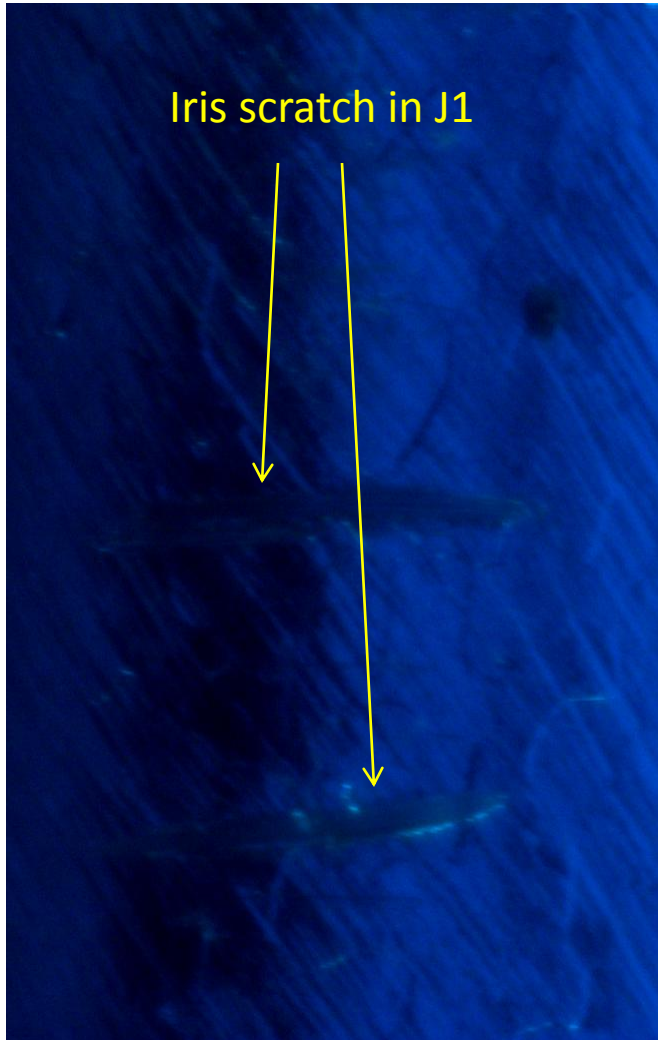
Damages from Handling/Fixture
